IMPROVING RELIABILITY ON MV DISTRIBUTION LINE IN THE SYSTEM CONNECTED TO DISTRIBUTED GENERATOR IN SOUTH SUMATRA, INDONESIA, A CASE STUDY

Bob Saril
PT PLN (Persero) – Indonesia
bob.saril@pln.co.id

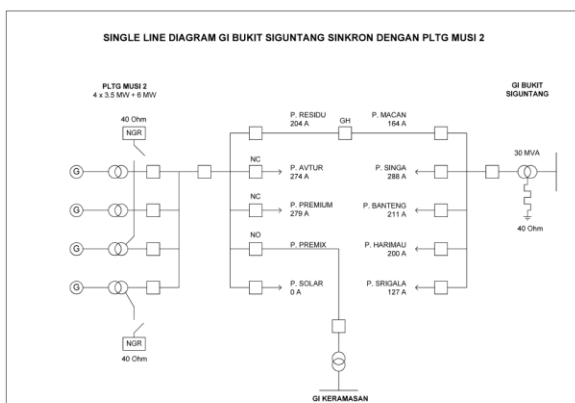
Figure 1 Single Line Diagram IPP Musi II

In the Musi II MV System, the relay selectivity tends to be the major problem. The sympathetic trip sometimes occurred simultaneously in 20 kV Substation bus. One feeder of the bus in substation was faulted leading to the operation of tie feeder relays. The open tie feeder caused the overload of the incoming of bus IPP. All the feeders supplied by the IPP Bus was black out.

The flow of power in the tie feeder was from the substation to the 20 kV IPP Bus since the load were far bigger than ke capacity of the plant.
