NETWORK ISLANDING – A REAL EVENT

Miguel LOURO
EDP Distribuição – Portugal
miguel.louro@edp.pt

ABSTRACT

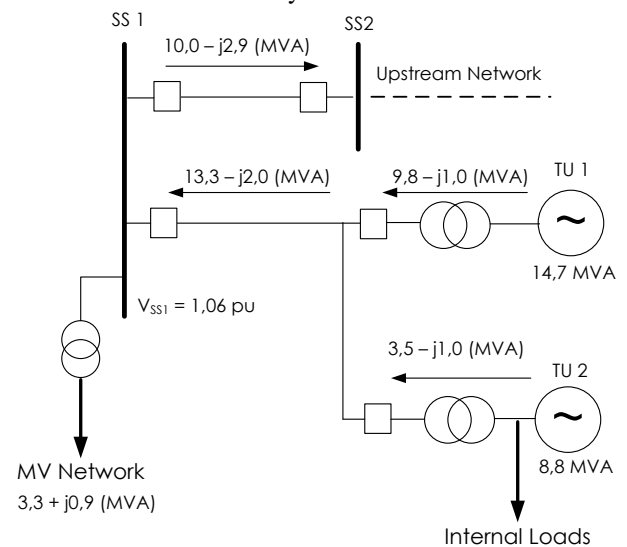
Figure 1. Network before islanding

Thermal Unit One (TU1) is a pure generation plant while TU2 has significant internal loads. Both units are prepared to work in island if the circuit breaker that connects them to the grid opens and only in that circumstance, according to the plants operators. This is meant to ensure that the thermal process is not, significantly, affected by network faults and that the plant is able to reconnect to the network as soon as the voltage returns to standard values.

The neutral arrangement for the 60kV network in Portugal is solidly grounded. However, the neutral is grounded solely at the EHV/60kV substations. The transformers of both thermal units are not connected to ground in the 60kV side.

In the moments prior to the islanding the power flow through the network was the one shown in Fig. 1.

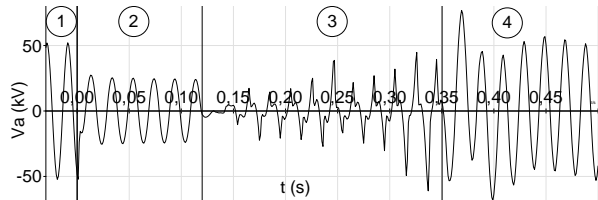
Figure 2. Phase A voltage seen in the 60kV busbar of SS1

On a spring day in the year of 2011 a phase-to-ground fault occurred in phase A of the line between SS1 and SS2. The line distance protection on SS2 detected the fault in zone 1 and tripped the breaker in 0,14s. The under-voltage protection at TU1 and TU2 did not trip because the phase-to-phase voltage decreased to 82% V_N, at this voltage the protection would take 1s to trip.

The transformers of SS1, TU1 and TU2 have isolated 60kV neutrals so there was not enough zero sequence current to trip the line protection in SS1.

After the breaker in SS2 opened the fault remained in an isolated neutral system with an almost zero fault current, which led the fault to self-extinguish ([1]). After this

Figure 2, which depicts the voltage in phase A of SS1, helps to clarify the sequence of events:

- Zone 1 – pre-fault
- Zone 2 – phase-to-ground fault fed by SS1 and SS2
- Zone 3 – phase-to-ground fault fed by SS1 in isolated neutral
- Zone 4 – post-fault after the fault self-extinguished

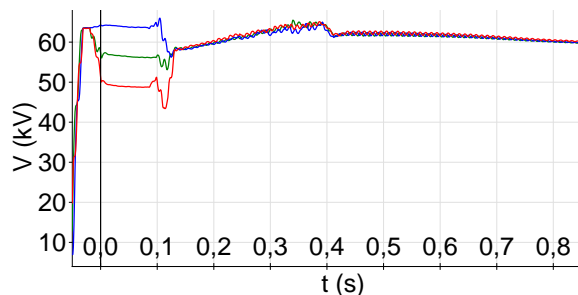
Figure 3. Phase-to-phase voltages seen in the 60kV busbar of SS1

moment an island had been formed. The phase-phase voltage reached 100% V_N after the breaker trip at SS2 (figure 3).

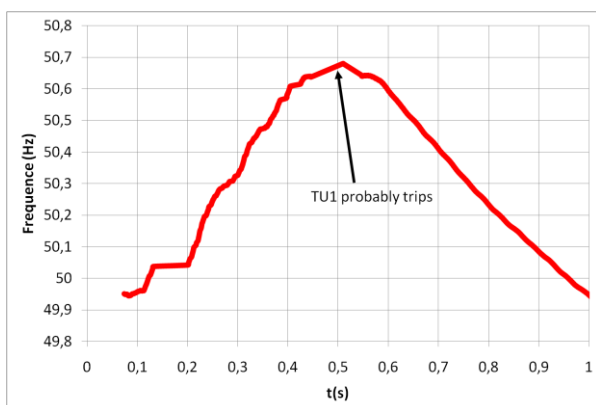
Figure 4. Island frequency in the initial stages

After the formation of the island the frequency started to rise because this part of the network was exporting about 10MW to the upstream network ([2]). The frequency variation for the first second of the island formation is shown in figure 4.

The frequency continued to rise up to 50,7Hz and at this point it began to decrease. This was probably due to the trip of TU1 by the over-frequency relay at the connection point to the grid, which was set at 50,3Hz (in accordance with older regulations). The trip may have taken 0,2s (the frequency 50,3Hz occurs 0,2s before the trip) to be concluded due to the protection's internal frequency measurement algorithm and the circuit breaker opening time.

The over-frequency relay of TU2 did not trip because it was set at 51,5Hz in accordance with newer regulations. After the TU1 trip the frequency starts to decrease reaching 49,95Hz at the end of the disturbance record. This sudden decrease maybe due to a lower inertia of TU2, however, due to the lack of data from the facility it was not possible to confirm this hypothesis.

SS1 doesn't have a continuous frequency register with enough time definition to allow the detection of these phenomena. So, it is not possible to present the frequency after the initial fault (the data of figure 4 was calculated from the disturbance record of the initial fault – figure 2).

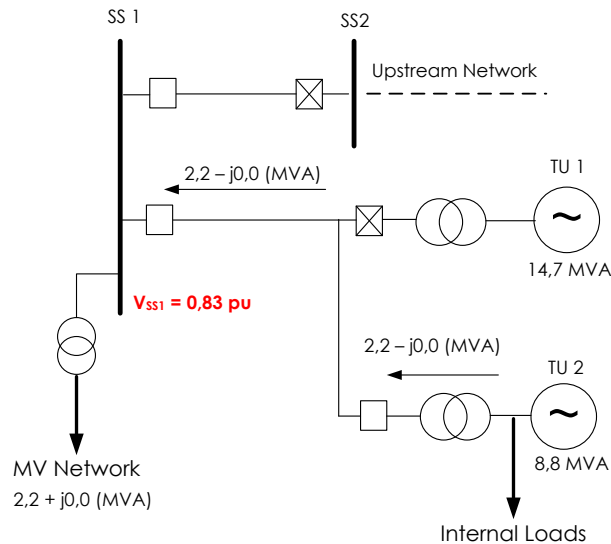
Figure 5. Steady state power flow after islanding

After the island formation there is a lack of information because the disturbance records are limited in time. However, from the disturbance record taken at the instant of the island break-up it is possible to determine the steady state situation of the island by using the pre-event data. The power flow is shown in figure 5.

In the estimated steady state condition SS1 MV loads were being fed by TU2. However, TU2 was not supplying reactive power and therefore the voltage at busbar 1 was about 83% of the nominal value. In the MV level the voltage was about 90% V_N .

During the operation in island condition the voltage supplied to the costumers was below the levels of EN50160. This meant that quality of the supply was not being assured although it is solely the responsibility of the DSO. If there had been complaints EDP would probably

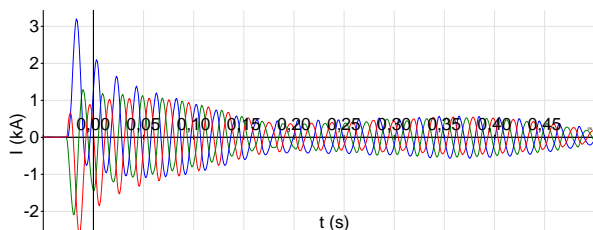
Figure 6. Current after network restoration (includes inrush current from SS1 transformer)

After realizing that there was a part of the network in island the Dispatch centre ordered the line breaker at SS2 to close. Unfortunately there was a malfunction in the synchro-check which allowed the circuit breaker closure to occur with a large angle between the voltages in the SS2 busbar and the line. This malfunction, which manifested itself only for manual commands, was later repaired.

The current after the restoration instant was large (3kA peak) because of the inrush current in the transformers (mainly the one at SS1) in the first few cycles and then due to the generator's need to align itself with the network's angle in the following second.

However, there was a voltage drop at the TU2 site as an undesired effect of the synchro-check malfunction. This led to a trip of the under-voltage protection in the
