## METHODOLOGY FOR THE UTILISATION OF COMPACT DISTRIBUTION LINES IN COASTAL AREAS

*This paper presents the main results of a research project developed by the electrical utility CELESC, aiming at the preparation of a guideline for the utilisation of compact distribution lines in places with trees near the coast. Emphasis should be given to the development of an accelerated ageing test that would be able to reproduce, in the laboratory, the typical damage observed in polymeric material installed in places with heavy pollution. Different types of line spacers available in the Brazilian market were tested and the results of the investigation provided important information concerning the application of compact distribution lines in coastal areas.*

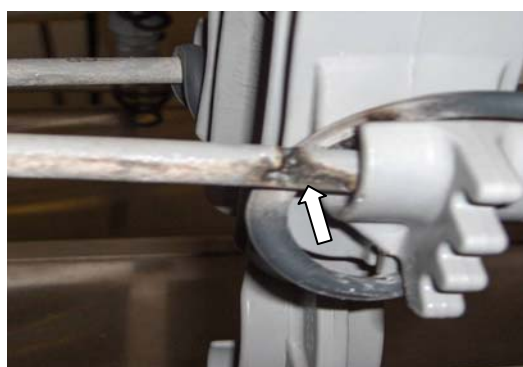
It should be emphasized that the utilisation of the accelerated ageing test enabled the study of polymeric materials in the laboratory. Therefore, this test can be used as an important tool to evaluate the performance of different polymeric materials in aggressive environments. Figure 1 shows details of the typical kind of damage observed in the covered cable during the tests.

Figure 1 – Details of the typical kind of damage observed in a covered cable.

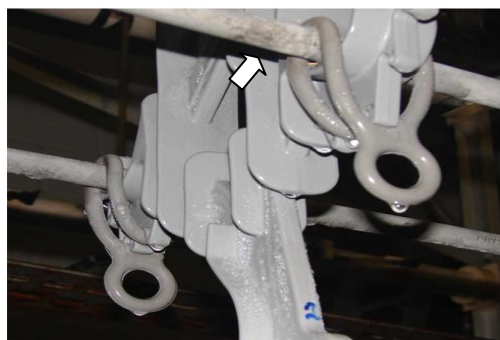
Therefore, the accelerated ageing test was performed in line spacers, class 15 kV, of two manufacturers. These line spacers were first submitted to the corona test. Figure 3 shows details of the degradation which happened in the tests. The results can be seen in Table IV.

Figure 3 – Tracking and erosion in a covered cable.

The accelerated ageing test showed that line spacers that present corona discharges in the corona test will present tracking and erosion in the accelerated ageing test. Then, the corona test is an important tool to be used in the choice of polymeric materials that should be submitted to the accelerated ageing test.
