COMPOSITE INSULATOR DIAGNOSTICS IN SERVICE AND CONDITION MONITORING IN VERY HARSH COASTAL ENVIRONMENT OF IRAN

This paper present an applicable program for diagnostics and condition monitoring (CM) of 20 kV distribution line which is located in a coastal district which pollution level of this region is classified at very heavy category as shown in figure1.with pilot project in this area, this model of CM presented the best tool for Evaluation of reminded life of all kind of insulators.

GESHM ISLAND PILOT PROJECT

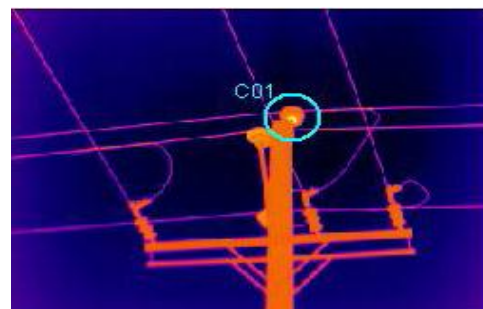
Visual inspection is the most commonly used inspection technique. Binoculars are used to perform remote visual inspections With IR, the temperature distribution along the insulator axis is measured by means of an infrared camera, searching for hot spots associated with possible local defects as shown in figure3

Figure3. An example of IR defect detection of in-service insulators
In field inspection step long time leakage current

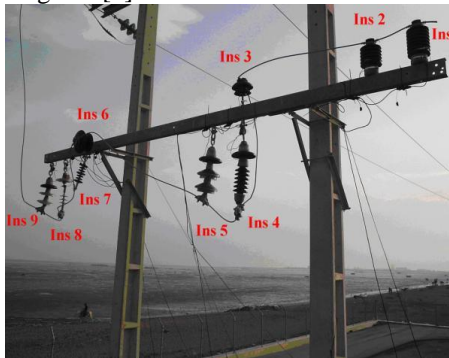
parameters monitoring of sample (5 years) has been selected as a one of main strategy. The assessed composite insulator installed at natural pollution test station beside of other type of porcelain and composite insulators. All different leakage current parameters are also investigated.[3]

Figure 4. Online leakage current monitoring

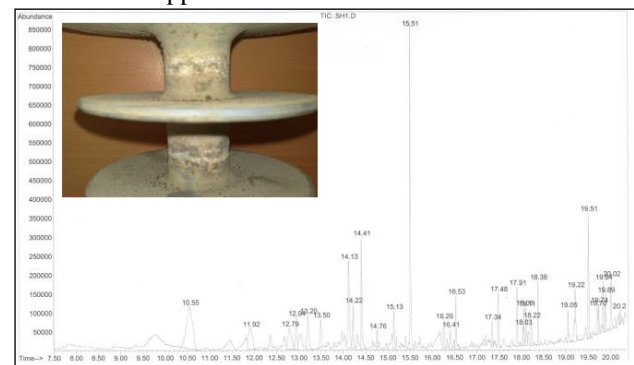
Fig.6: gas chromatograms for composite insulator sample from level 3

Fig. 6 shows a gas chromatograms for composite insulator sample from level 3. The position of each peak in GC spectrum corresponds to an increase in molecular weight of the polymer matrix by one dimethylsiloxane unit, with the molecular weight increasing from the left to the right of the spectrum. The peak height is indicative of the relative abundance of each component. The gas chromatograms have been normalized for sample weight, so that the relative peak areas or peak heights can be consider. As the polymer matrix of silicone materials is primarily formed of polydime-thylsiloxane [SiO(CH₃)₂]_n the gas chromatograms indicate the distribution of homologous short-chain siloxane in the polymer. Successive peaks for a virgin composite insulator in the spectra correspond to a unit increase in the number of dimethylsiloxane units (n = 3; 4; 5;)

figure.6, the decrease of the peak height corresponding to mid-weight siloxanes ($n = 14$ to 16) .it comes from very heavy duty condition.

Thus a reduction in the mid-weight siloxanes and generation of low molecular weight siloxanes appears to be characteristic of surface aging of this sample . The low molecular weight species are likely produced through polymerization of the polydimethylsiloxane matrix during the aging process.some reports says that insulators from this group had fault after two up to three year in service

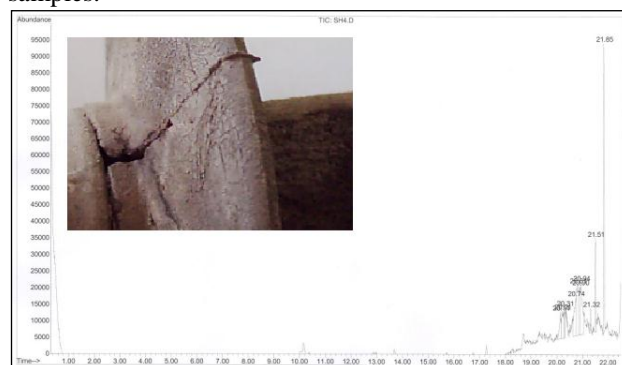
Fig. 8 shows a gas chromatograms for the aged composite insulator in level 5 where the decrease of the peak height corresponding to mid-weight siloxanes ($n = 20$ to 22) and the low molecular weight siloxanes increased as a result of final aging. Thus a reduction in the mid weight siloxanes and generation of low molecular weight siloxanes appears to characteristic of surface aging of samples.

Fig8: gas chromatograms for composite insulator sample

from level 5
