DISRUPTIVE SOLUTION TO MITIGATE RISK AND INCREASE EFFICIENCY IN EDP DISTRIBUIÇÃO, OVERHEAD LINES INSPECTIONS

ABSTRACT

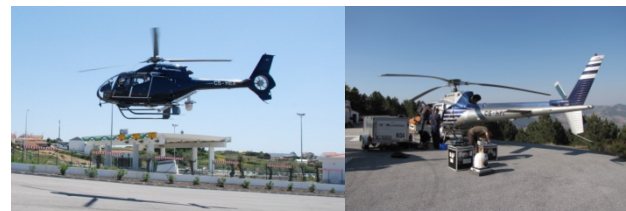
Figure 1 – Helicopters used by Labelec

EDP Distribuição, (EDP Group) is the Portuguese Distribution system operator (DSO), managing about 80 thousand kilometers of HV/MV overhead lines. The company has been performing helicopter inspections of overhead electric transmission and distribution lines since 1995, through one of the other EDP group companies, LABELEC, with tangible benefits for its maintenance programs. These inspections include an Infra Red (IR) camera, a Daylight TV camera and, recently, an Ultra Violet (UV) camera (for daylight corona detection) and a Digital Single-Lens Reflex (DSLR) camera for quality digital photos, all contained in a high stabilization

gimbal. A LiDAR system is also used, since 2008, for making measurements and geo-referencing abnormal distances between trees and other obstacles and the conductors. Visual inspections benefit from the use of stabilized binoculars. All these sensors may be present in the same helicopter, allowing for simultaneous multiple inspections in a single flight.

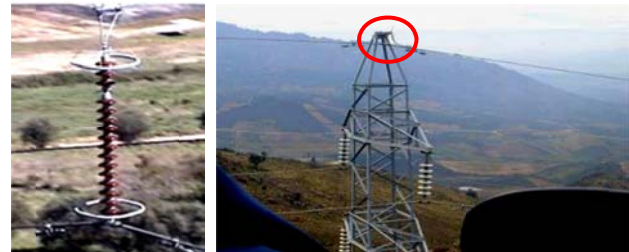
Figure 4 – Broken insulator; broken ground wire

The visual inspector detects and takes notes of every visual fault observed on the line, using stabilized binoculars to help analyze faults whenever necessary. He also helps the pilot in detecting obstacles in the helicopter

path. Visual faults, as well as IR faults, are geo-referenced and may be photographed using the DSLR camera.

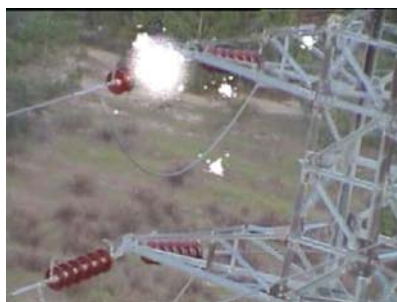
Figure 6 – UV inspections - damaged ceramic insulator

Daylight corona detection, using a UV camera, allows the detection of corona activity originated by dirty (due to coastal salt, industrial vapors and dusts, cement dust, among others), damaged insulators (cracked porcelain insulators, rusted cement metal caps on porcelain insulators, damaged composite insulators) or damaged conductors. Some of these faults are very difficult or even impossible to detect visually. Only a UV camera alert will allow suspecting of their existence.

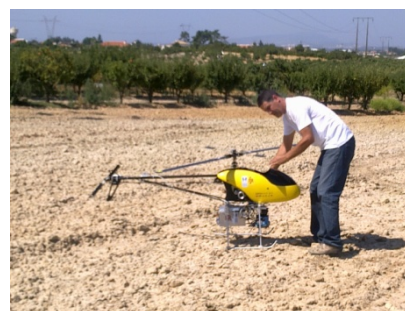
Figure 8 – AIRTICI UAV.

AIRTICI UAV (Figure 8) was tested in the inspection of an HV power line pole near Setubal. The UAV was equipped with visual camera for snapshot photos, thermographic camera and a small LiDAR system. The current solution is able to autonomously follow predefined waypoints but it has shown to be very dependent on the pilot, as is absent of collision avoidance sensors or other of the safety functions that already appear in quadcopter models.

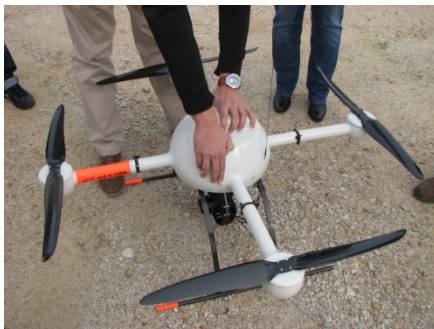
Figure 10 – SKYEYE UAV.

SKYEYE is supplying a 4-rotor quadcopter UAV solution from a German manufacturer. It can be equipped with visual and thermographic camera and has a set of safety functions similar to the ones used by UAVISION (except for the collision avoidance sensors). SKYEYE performed a test flight in a MV (30 kV) overhead power line of EDP Distribuição. The UAV from SKYEYE (Figure 10) is more intuitive and easy to handle for the operator and revealed a more stable flight when compared with the other solutions tested by EDP Distribuição.
