## MV/LV SUBSTATIONS – SOLUTIONS TO IMPROVE THE TECHNICAL QUALITY OF SERVICE

### ABSTRACT

*The Technical Quality of Service has been a constant concern in EDP Distribuição. Between 2008 and 2010 the Portuguese Distribution System Operator (DSO) carried out significant efforts to improve the index that measures the quality of service in Portugal, the Average Interruption Time (AIT). Currently the focus is on reducing certain asymmetries that still persist between different areas.*

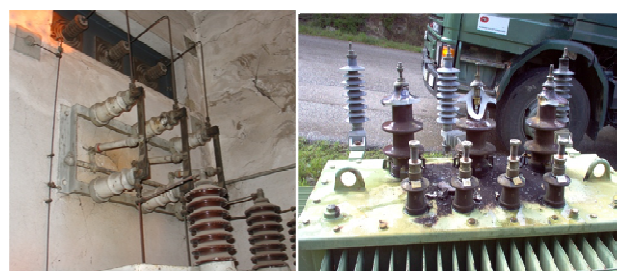
MV/LV substation main failure modes, (see figure 2), and correspondent root causes are [2]:

Fig. 2 – MV/LV Substations Typical Failure Mode

- i) Building structure degradation: aging, deficient maintenance, vandalism and theft, sea and/or industrial pollution, deteriorated waterproofing, water infiltration;
- ii) Power transformer local sparking, internal or external, or corona activity along the insulation surface: dirt wall bushings, animals, vandalism and theft, oil leak, insulating deterioration, inadequate load regime;
- iii) Cells and busbars local sparking, internal or external, or corona activity along the insulation surface: dirt insulators, overheat, animals, corrosion, humidity, dielectric loss, manufacturing defect, premature aging;

The major interruptions in MV/LV substations are caused by insulator flashover, also on modular and enclosed MV switchgear.

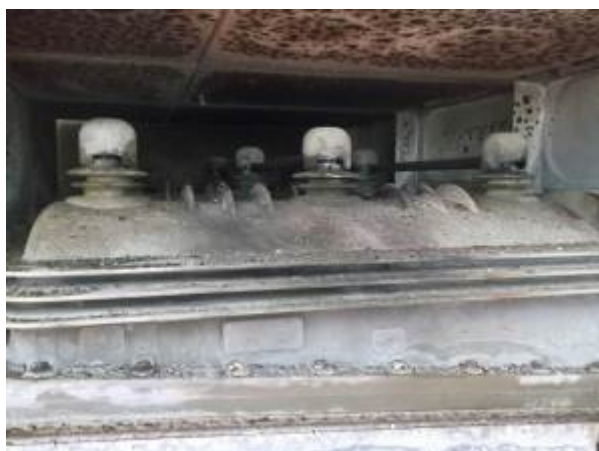
The pollution, acid condensation, etc. over the surface of insulators causes more degradation which causes more acid and ozone, creating a vicious cycle with flashover at the end, (see figure 3).

Fig. 3 – Example of severe degradation

The causes to these problems are local sparking or corona activity along the surface of the insulation. Discharges cause a slow deterioration of the insulator surface in the long term through three mechanisms: firstly through slow erosion by ionic bombardment of ions in the sparks, secondly by chemical degradation of the insulation material and thirdly from carbonization of the material surface.

Partial Discharges (PD), local sparking and corona discharges have enough energy to create O<sub>3</sub> and NO<sub>2</sub>; the first degrades the polymeric materials and the last, combined with water (vapour or deposited by condensation), produces nitric acid that corrodes the metallic –steel and copper– surfaces and creates electrical conducting paths through insulator surfaces.

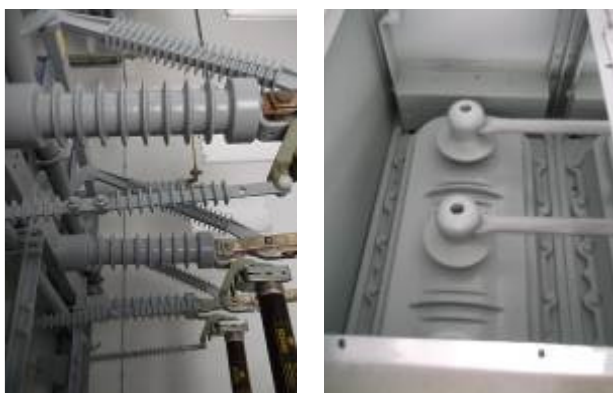
Fig. 5 – Final results

In the end, the applicators ensure that there is a layer of, at least, 0.35mm of dry RTV over the insulators surfaces. After application the insulator surfaces are rehabilitated and all surface electrical activity is stopped: no noise, no smell, no overheat, avoiding further degradation (see fig 5).

The application is made with an airless spray machine

because thinners or solvents to decrease viscosity of Si-Coat are not allowed to be added.
