USE OF COMBINED APPROACHES TOWARDS MITIGATING FAULTS CAUSED BY LIGHTNING ON TNB DISTRIBUTION OVERHEAD LINES

Mohd Faris ARIFFIN
Distribution Division, TNB – Malaysia
farisar@tnb.com.my

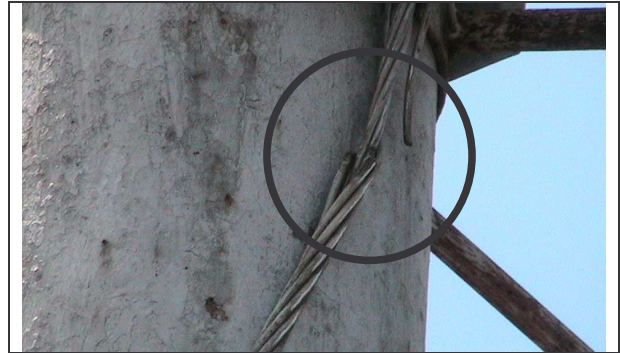
ground. Photo 2 shows the risk of using galvanized steel wire as a down lead conductor. The wire strands have snapped probably due to the high energy strike current:

Photo 2: Snapped Strands of Steel Down Lead Conductor

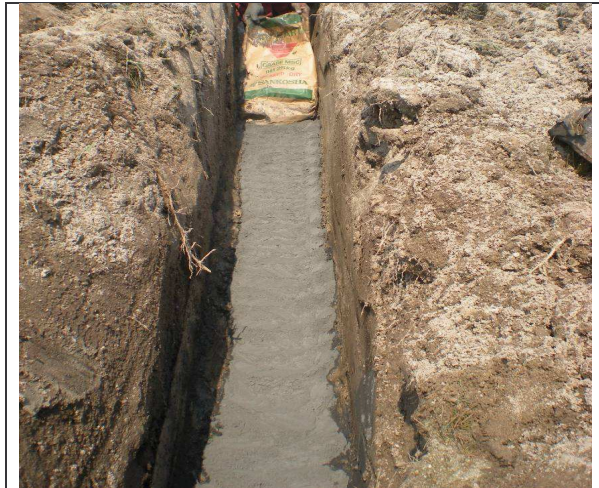
Photo 3 below illustrates the application of earth enhancing compound for pole footing resistance improvement:

Photo 3: Applying Earth Enhancing Compound

Fortunately, with the use of earth enhancing compound, the soil resistivity can be reduced to improve the overhead line pole footing resistance. Two commonly used earth enhancing compound is being tested on 11kV Kampar to Gopeng overhead line that runs on sandy ground [3]. The only concern with earth enhancing compound is the risk for it to be washed away by water during heavy rain. Thus, the compound should solidify when in contact with the earth moisture. Table 1 below indicates the improvement of soil resistivity with the application of the earth enhancing compound:

The earth enhancing compound at these two poles was applied between July and August 2011. In order to ensure that the compound still retains its properties, the earthing resistance at these two poles was measured again in October 2011. Table 2 shows that the earthing resistance has reduced further:

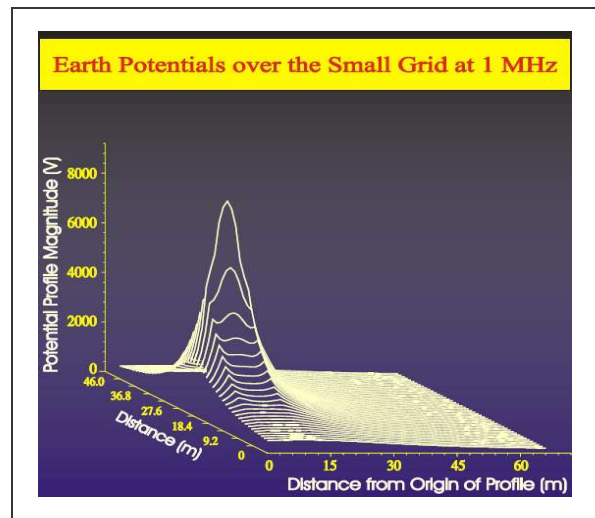
In order to ensure fast discharge of the high energy, high frequency lightning current, the correct configuration should be used to ensure that the lightning current takes the shortest path to earth and is eventually effectively discharged to ground [3]. From the EPA data collected in 2010, there seemed to be a misconception on effectively earthed distribution overhead line poles. High energy, high frequency lightning current behaves differently if compared to power frequency fault current when they are being discharged to earth. Figure 1 and 2 below shows the different resultant of earth potentials between high frequency lightning current and power frequency fault current when discharged to ground simulated using **Current Distribution, Electromagnetic Fields, Grounding and Soil Structure Analysis** or CDEGS:

Figure 1: Earth Potentials at 1 MHz

From the above general patterns, it can be observed that high frequency lightning current behaves differently when discharged to earth as compared to power frequency fault current. Thus, the pole earth connection should be configured in such a way to allow fast discharge of the high frequency lightning current through the shortest path to earth.

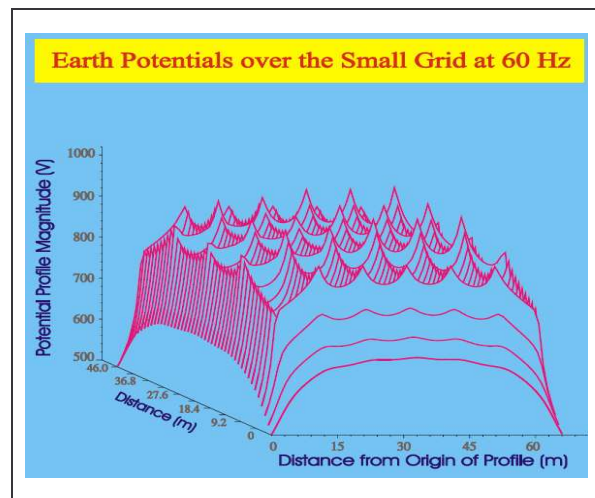
Figure 2: Earth Potentials at 60 Hz
