FIELD EXPERIENCE OF DIAGNOSIS TECHNIQUES FOR DETECTING DAMAGED INSULATORS OF OVERHEAD DISTRIBUTION LINE

ABSTRACT

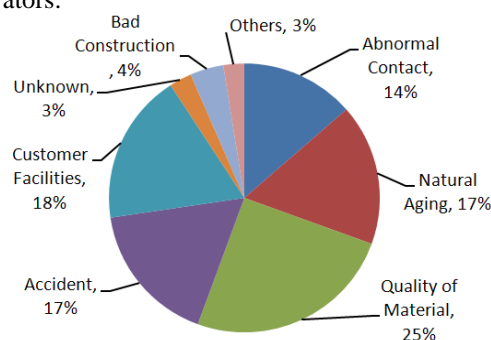
Figure 1 shows the result of cause analysis on distribution line interruption. The number of line faults can considerably reduce in scheduling line inspection. Patrol or simple visual inspection consists of walking, driving by equipment to identify obvious structural problems and hazards such as leaning poles, damaged equipments and broken insulators.

Figure 1: The causes of interruption on distribution line of KEPCO
